Manhole Inspection Summary

Manhole # S09MM_002MH

Insp Date: **1/21/09 11:45 AM**

Location Address: **3300 GWYNNS FALLS PKWY**

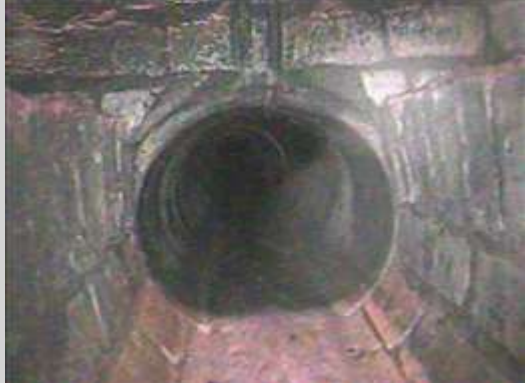
12 O'Clock Outflow

10 in. Circular Gravity Sewer
Pipe Out @ 12 O'Clock

Pipe Height: (in.) Direct
Pipe Material: **Clay** ☐ Pipe Lined
Invert Depth: **14.39** (ft.) Flow Characteristics: **Slow**
Deposits: ☒ None ☐ Mud ☐ Sludge ☐ Debris ☐ Grease
Silt Depth: (in.) Deposits Extent:
Infiltration: **None** Pipe Seal Cond: **Sound**

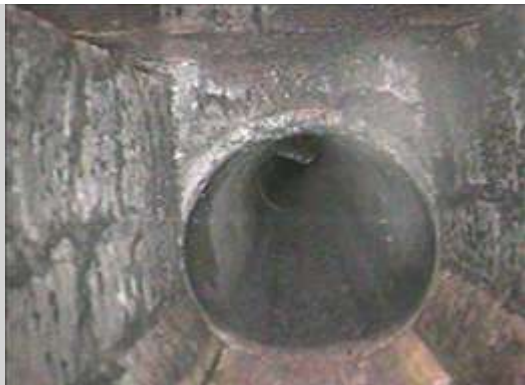
6 O'Clock Inflow

10 in. Circular Gravity Sewer
Pipe In @ 6 O'Clock

Pipe Height: (in.) Direct
Pipe Material: **Clay** ☐ Pipe Lined
Invert Depth: **14.53** (ft.) Flow Characteristics: **Slow**
Deposits: ☒ None ☐ Mud ☐ Sludge ☐ Debris ☐ Grease
Silt Depth: (in.) Deposits Extent:
Infiltration: **None** Pipe Seal Cond: **Sound**
